INVESTIGATION OF 14.5MM API SELF-
SEALING/CRASHWORTHY FUEL TANK MATERIAL

Goodyear Tire and Rubber Company

Army Air Mobility Research and Development
Laboratory

4. TITLE (and Subtitle) INVESTIGATION OF 14.5MM API SELF-SEALING/ CRASHWORTHY FUEL TANK MATERIAL		5. TYPE OF REPORT & PERIOD COVERED Final; June 1973 to June 1974

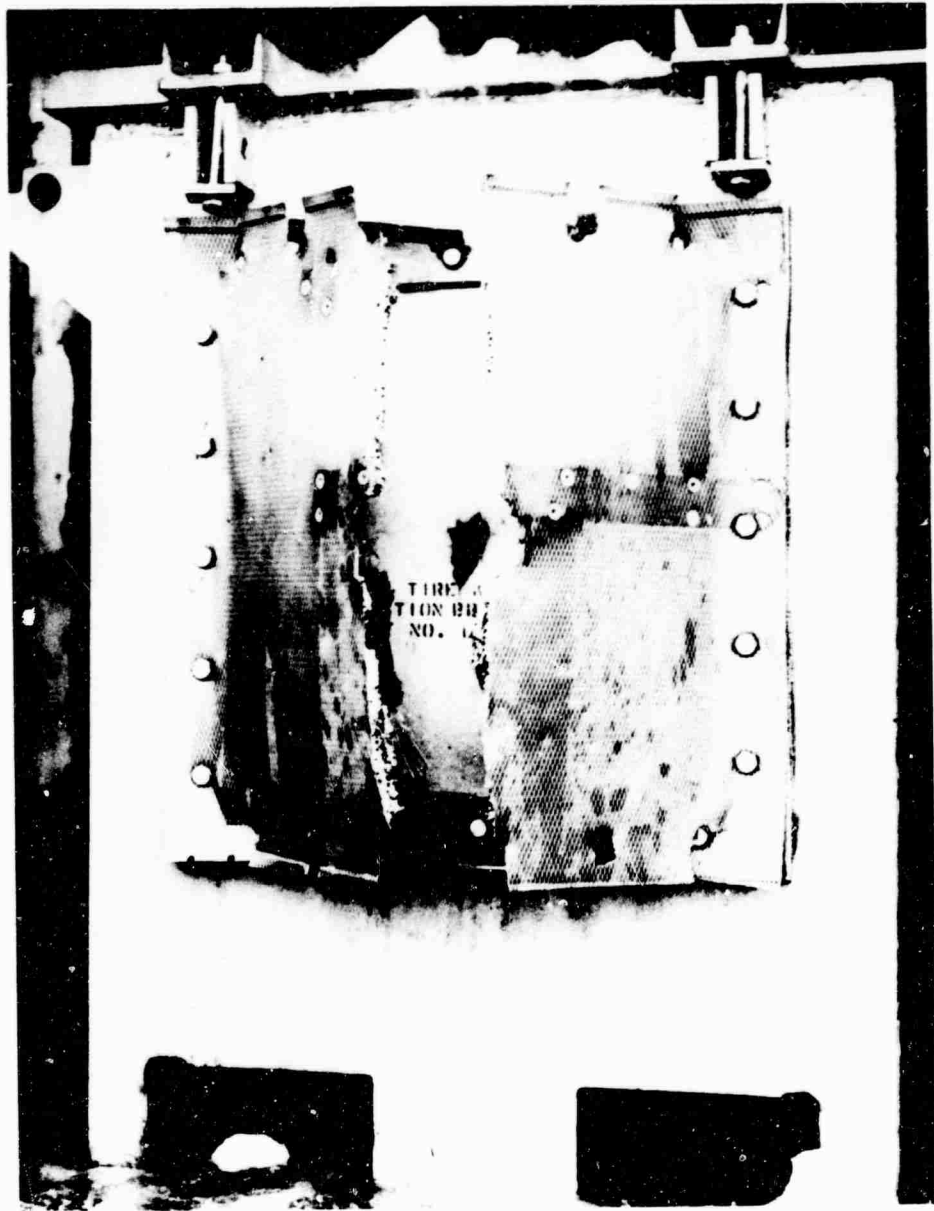
Figure 2. Panel Gunfire Structure With Panel.

Firing was conducted in accordance with Paragraph 4.6.12 of MIL-T-5578C, Rev C, except that 14.5mm API projectiles were used instead of .50-cal AP M2. The gunfire results are given in Table 6. The impacted tank and structure are shown in Figures 2 through 14.

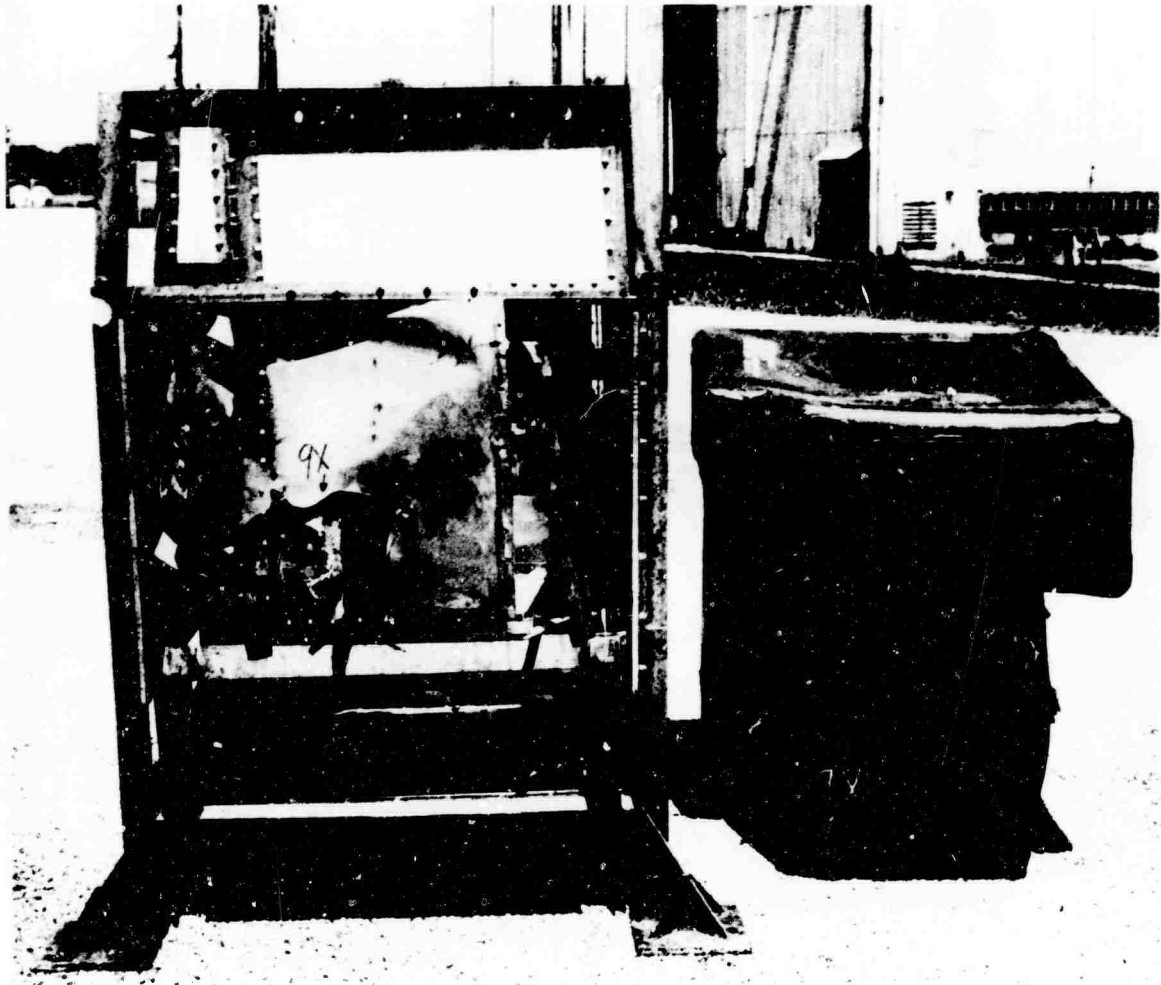
Figure 3. Tank and Structure (Forward Side) After Test Firing.

Round	Entry (deg)	Mode	Entrance	Exit	Structural Damage
1	90 to RH side	SI	Damp seal	FT damp seal at 1 min	LH panel split vertically at 1X.
2	90 to RH side	FT	Damp seal	No exit	Hydraulic ram damage to entry panel; frame bowed at rear panel.
3	45 to LH side	SI	Damp seal	FT SS to damp seal at 2 min	Extensive petaling at exit; RH panel bulged.
4	45 to aft side	SI	Damp seal	1/2T leakage not determined	Petaled panel at exit; bottom panel bulged.
5	90 to LH side	SI	Damp seal	1 1/2-in. wound FS at 2 min	RH honeycomb panel edge fastening failed.
6	45 to forward	SI	Dry	4-1/4-in. wound SS to drip at 2 min	Panel damaged by slicing shot at exit.
7	90 to RH side	3/4T	Dry	1-1/4-in. wound; damp seal	-
8	45 to bottom	SI	Dry	FT; no visible leakage	Blew open LH forward corner angle reinforcement.
9	90 to aft side	SI	Dry	3/4T damp seal at 1 min	4-1/2-in. -diameter hole in panel plus extensive petaling.

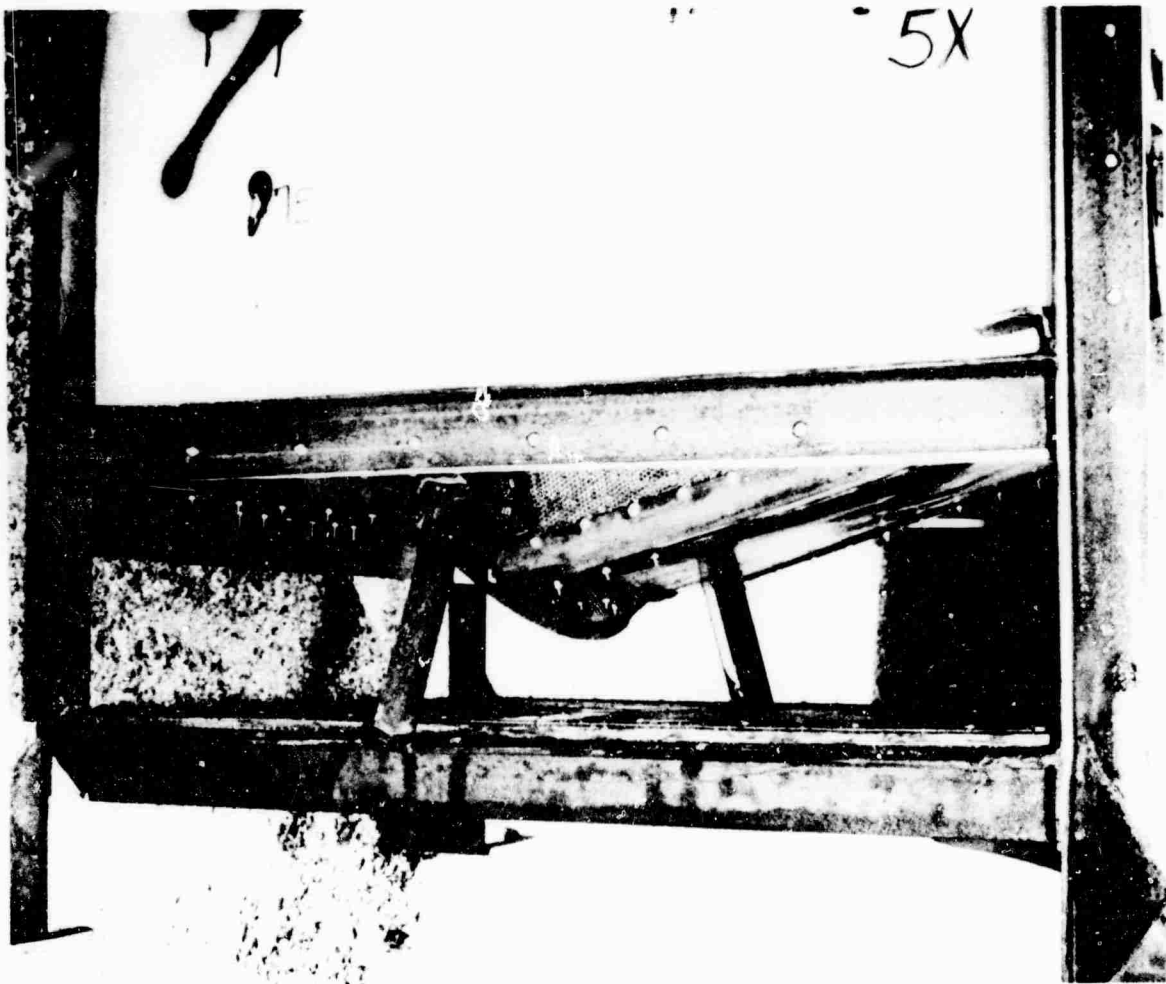
Figure 8. Damaged Structure (Bottom).

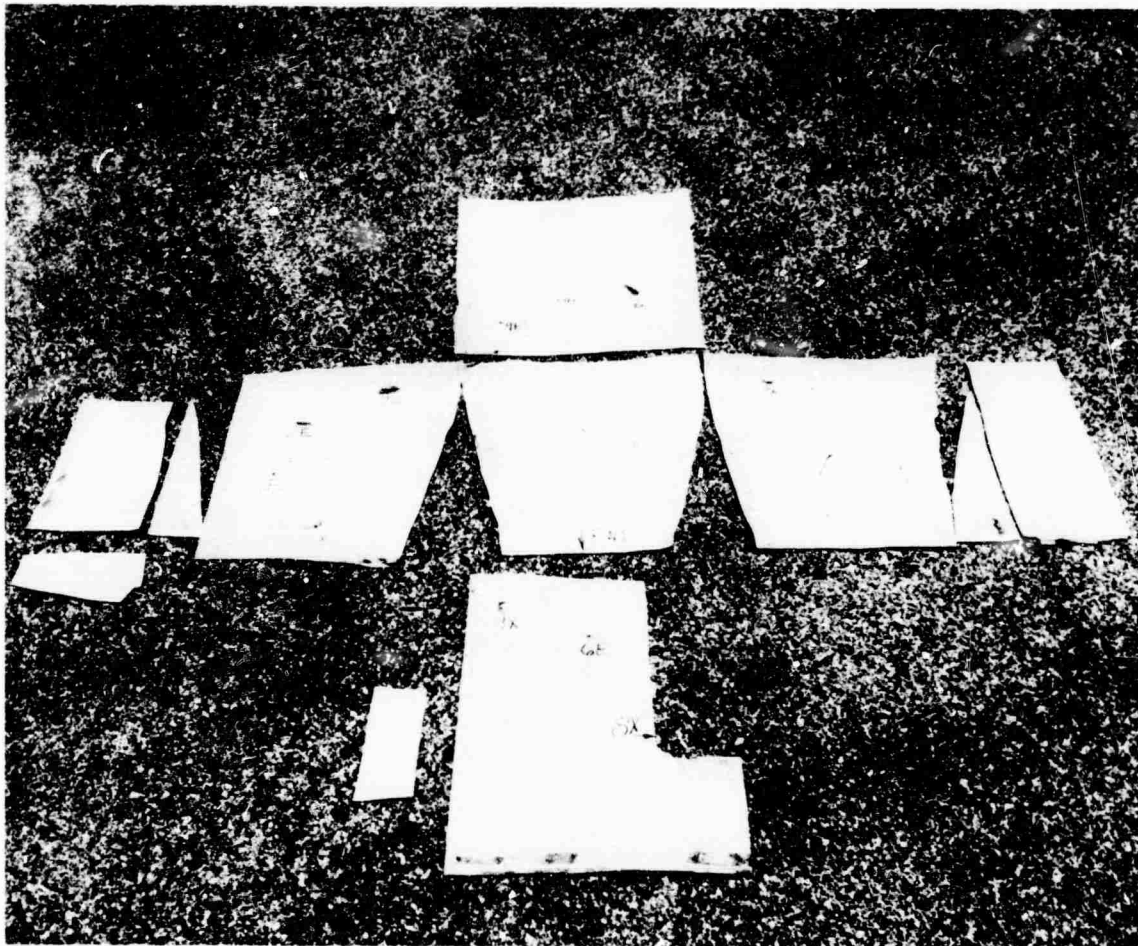
Figure 10. Backing Board Used in Gunfire Test.

A simulated cavity structure was made of structural steel angle iron frame and aluminum honeycomb panels. The interior of the cavity structure was lined with Goodyear BBC-5 backing board on the bottom and sides in preparation for the gunfire. The fuel tank was installed in the structure and filled two-thirds full of TT-S-735 Type I test fluid at ambient temperature.

1. Goodyear fuel tank construction ARM 666 (DX-680) met the Phase I test requirements of MIL-T-27422B, Amendment 1.
2. The crashworthy and ballistic response characteristics of construction DX-680 demonstrate its acceptability as a 14.5mm API ballistically tolerant crashworthy construction.
3. Goodyear BBC-5 backing board in conjunction with construction DX-680 demonstrated excellent ballistic response against 14.5mm API projectiles.

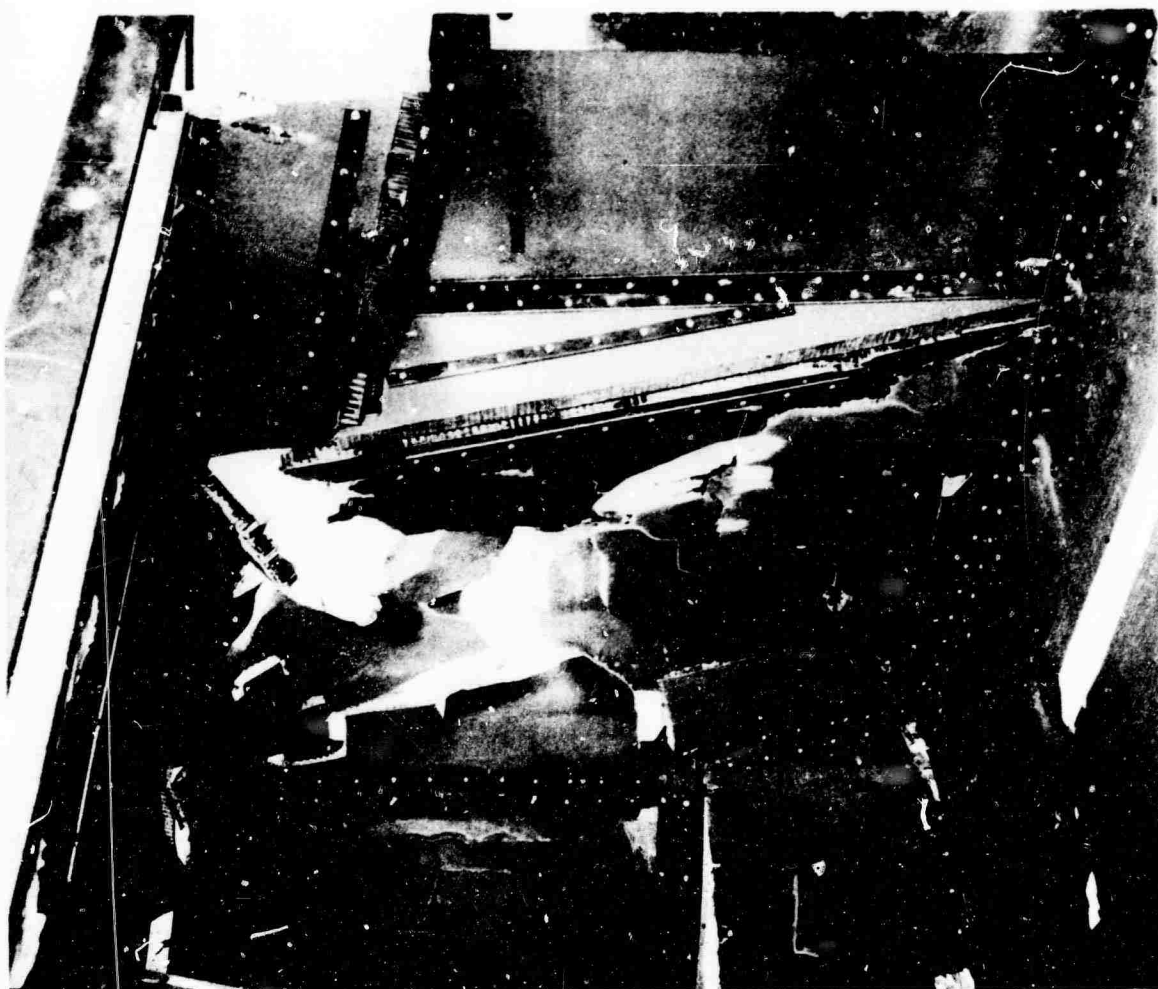
Figure 11. Honeycomb Panel of Structure (RH Side).

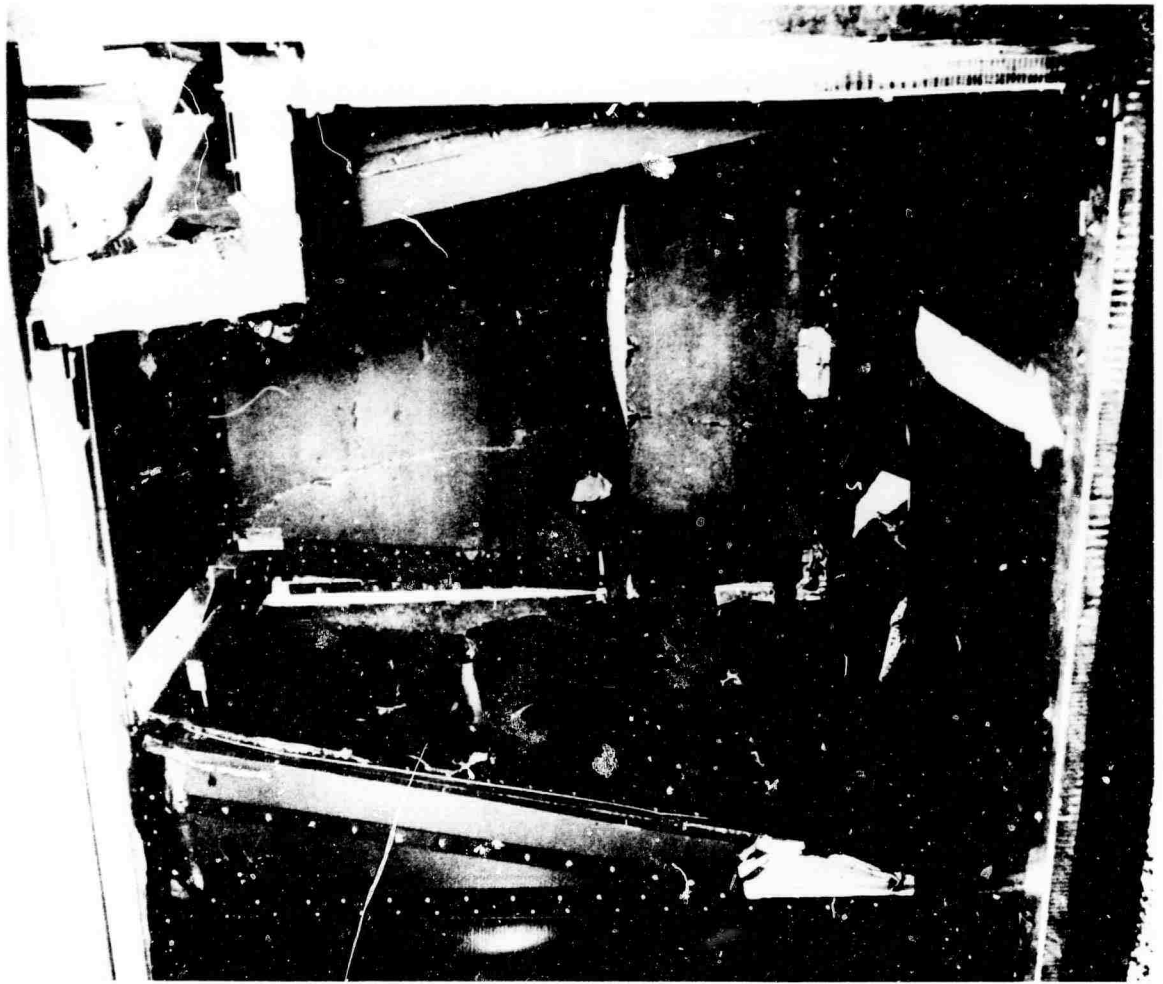
Figure 12. Honeycomb Panels of Structure
(LH Side, Aft Side, Bottom Panels).

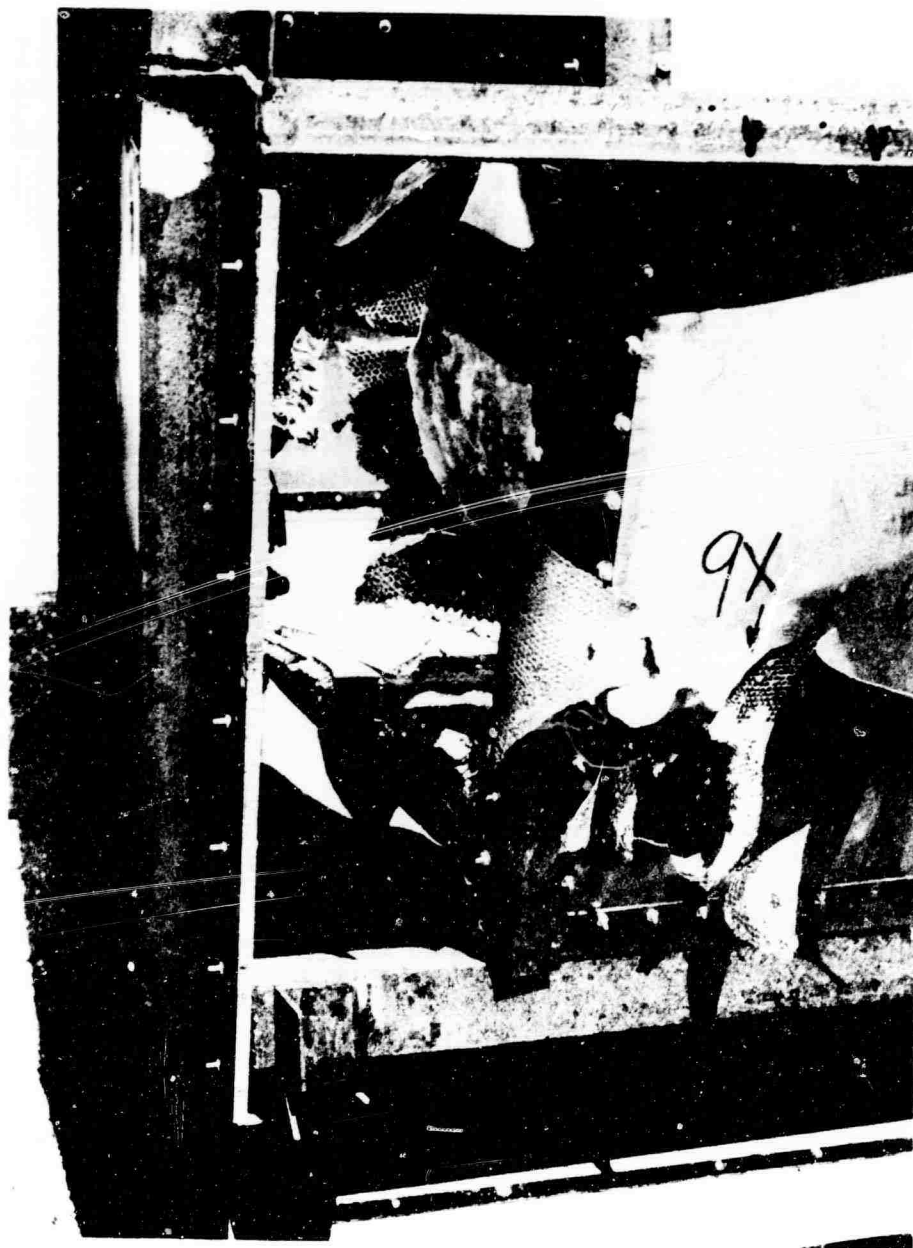
Figure 13. Damaged Structure From Exterior Side
(RH, Front Corner).

During the ballistic testing of the tank material, severe hydraulic ram damage to the simulated helicopter structure surrounding the tank was observed. If this tank material is adopted to provide 14.5mm API protection, it is recommended that additional measures be taken to ensure that the potential hydraulic ram forces generated by this round will not damage critical airframe components.

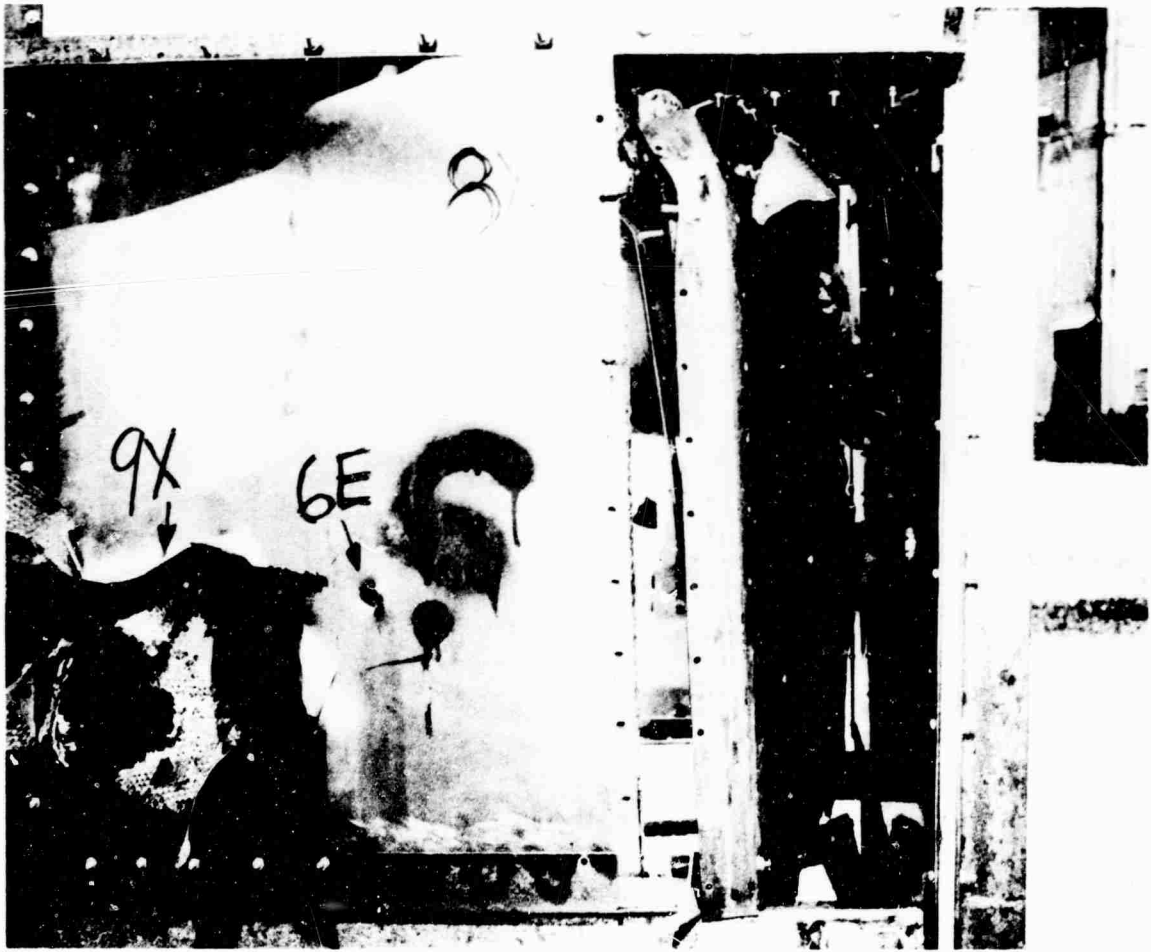
Figure 14. Damaged Structure From Exterior Side
(LH, Front Corner).
